Washgate

Route Management Plan

Washgate - Route Management Plan

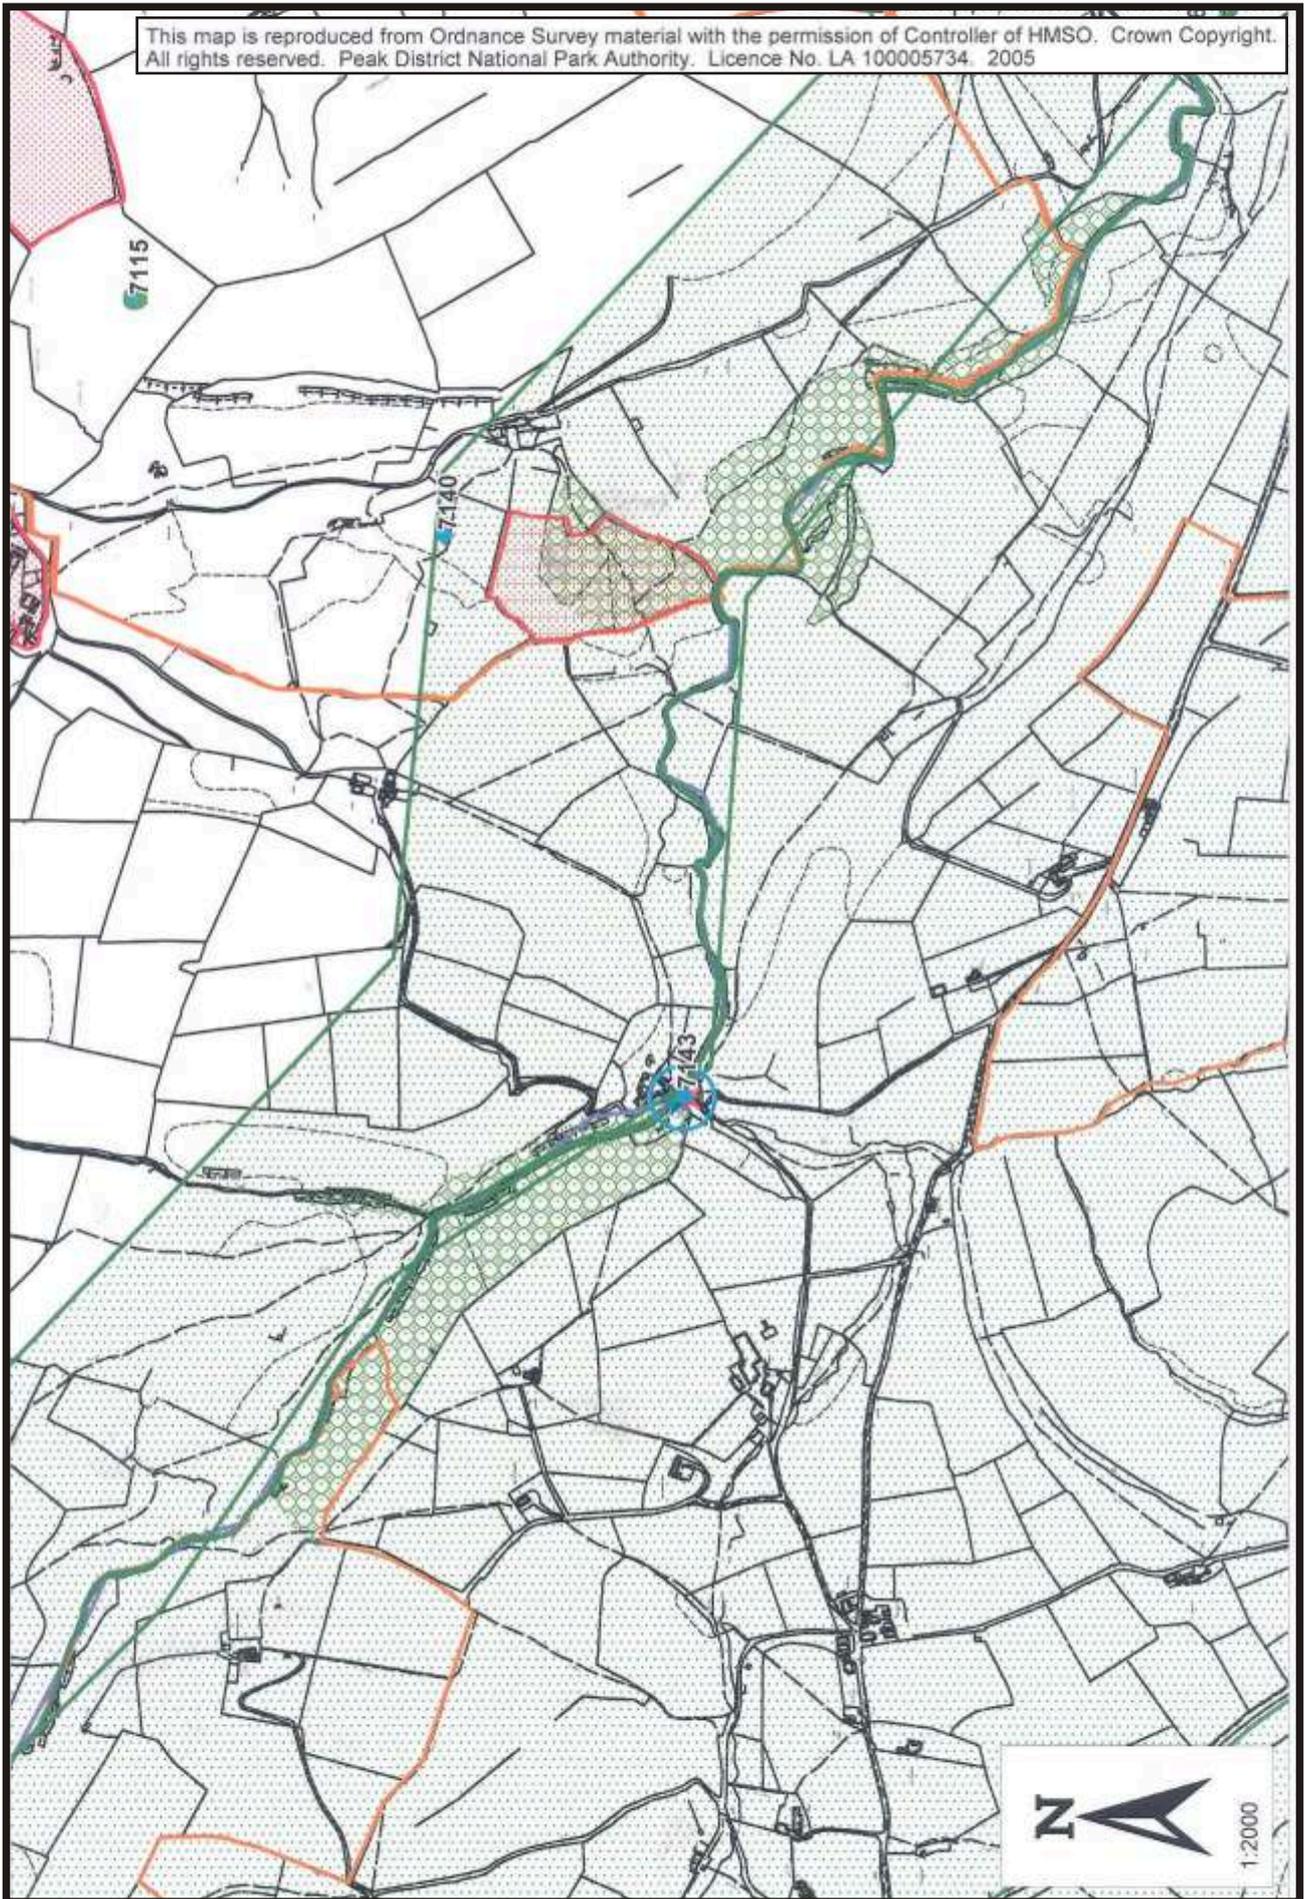
Map illustrating Cultural Heritage Features on or close to the route

The southern section of the route runs through land Enclosure of unknown date - with irregular fields. The land was enclosed prior to an 1827 Harpur-Crewe Estate Map; there is no earlier map evidence.
